Summary

Together with HP Wellscreen, we distribute the QRS in the Middle East and Africa. Recently we repaired a fresh-water well, at a large innovative dairy farm with tens-of-thousands cows in the Middle East. The QRS is a serious option for the repair of; leaks in wells, and modifications/repairs of wells. We have managed to repair a leaking downhole filter. By successfully running the QRS into the well, whereby the defective filter screens within 1 industrial fresh-water well have been blinded.

Background

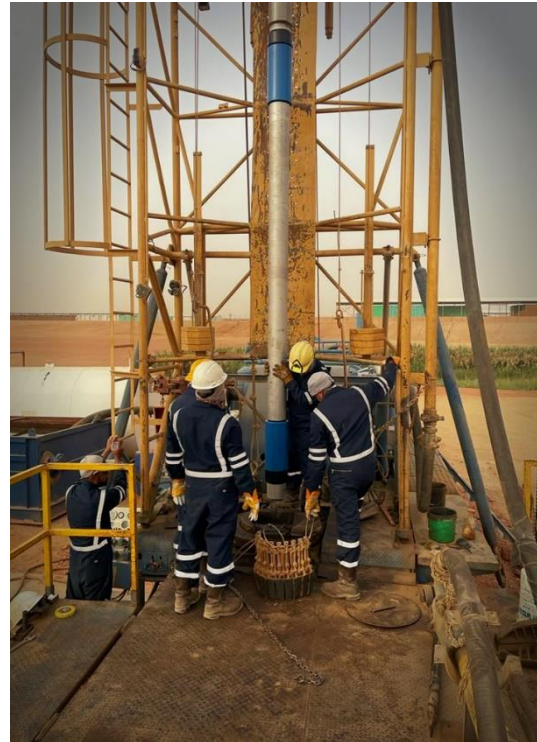
The pre-pack screen had a very high cost, and there are risks for installation. With the QRS the job could be done at a much lower cost and it was also a pretty straightforward quick fix. The only real constraint was identifying the failed area within the 100m well screen. We provided 2 QRS systems from stainless steel 304 with a core length of 4 meters. The 4-meter-long assembly has a running time of max. 4 days (we can provide a QRS with a run time of 12hr).

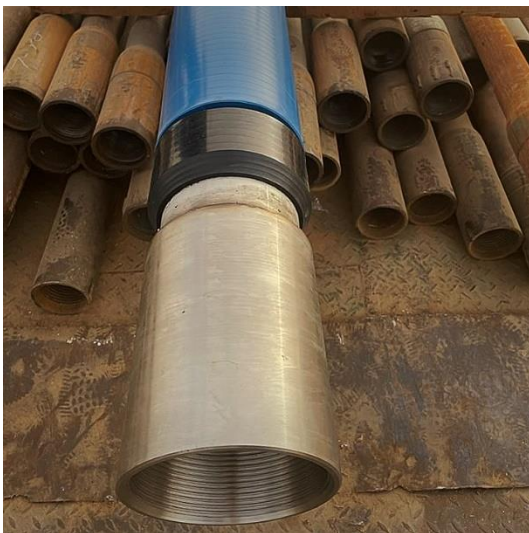
The installation cap has an opposite thread (right picture). After the release of the QRS (approx. +3 days), the 4-meter assembly is left behind, by turning the string in its regular direction and subsequently retrieving the string.

After installation, the QRS blinded the failed filter of the original stainless steel screen. The customer is very satisfied with the solution we also prevented a too-narrow passage for the rest of the filter, so there isn't any decline in production capacity or necessary services in a later stage. Based on the experience there was not even a recommendation for improvement. Overall we have provided a very straightforward solution. The lifetime of the well is extended by a small investment, without large modifications and changes. We hope this customer can use his well and feed his cows for the next decades without issues.
